# AIRCRAFT ACCIDENT REPORT

SKYWAYS INTERNATIONAL, INC.

DOUGLAS DC-7C, N296

REPORT NUMBER: NTSB-AAR-74-2

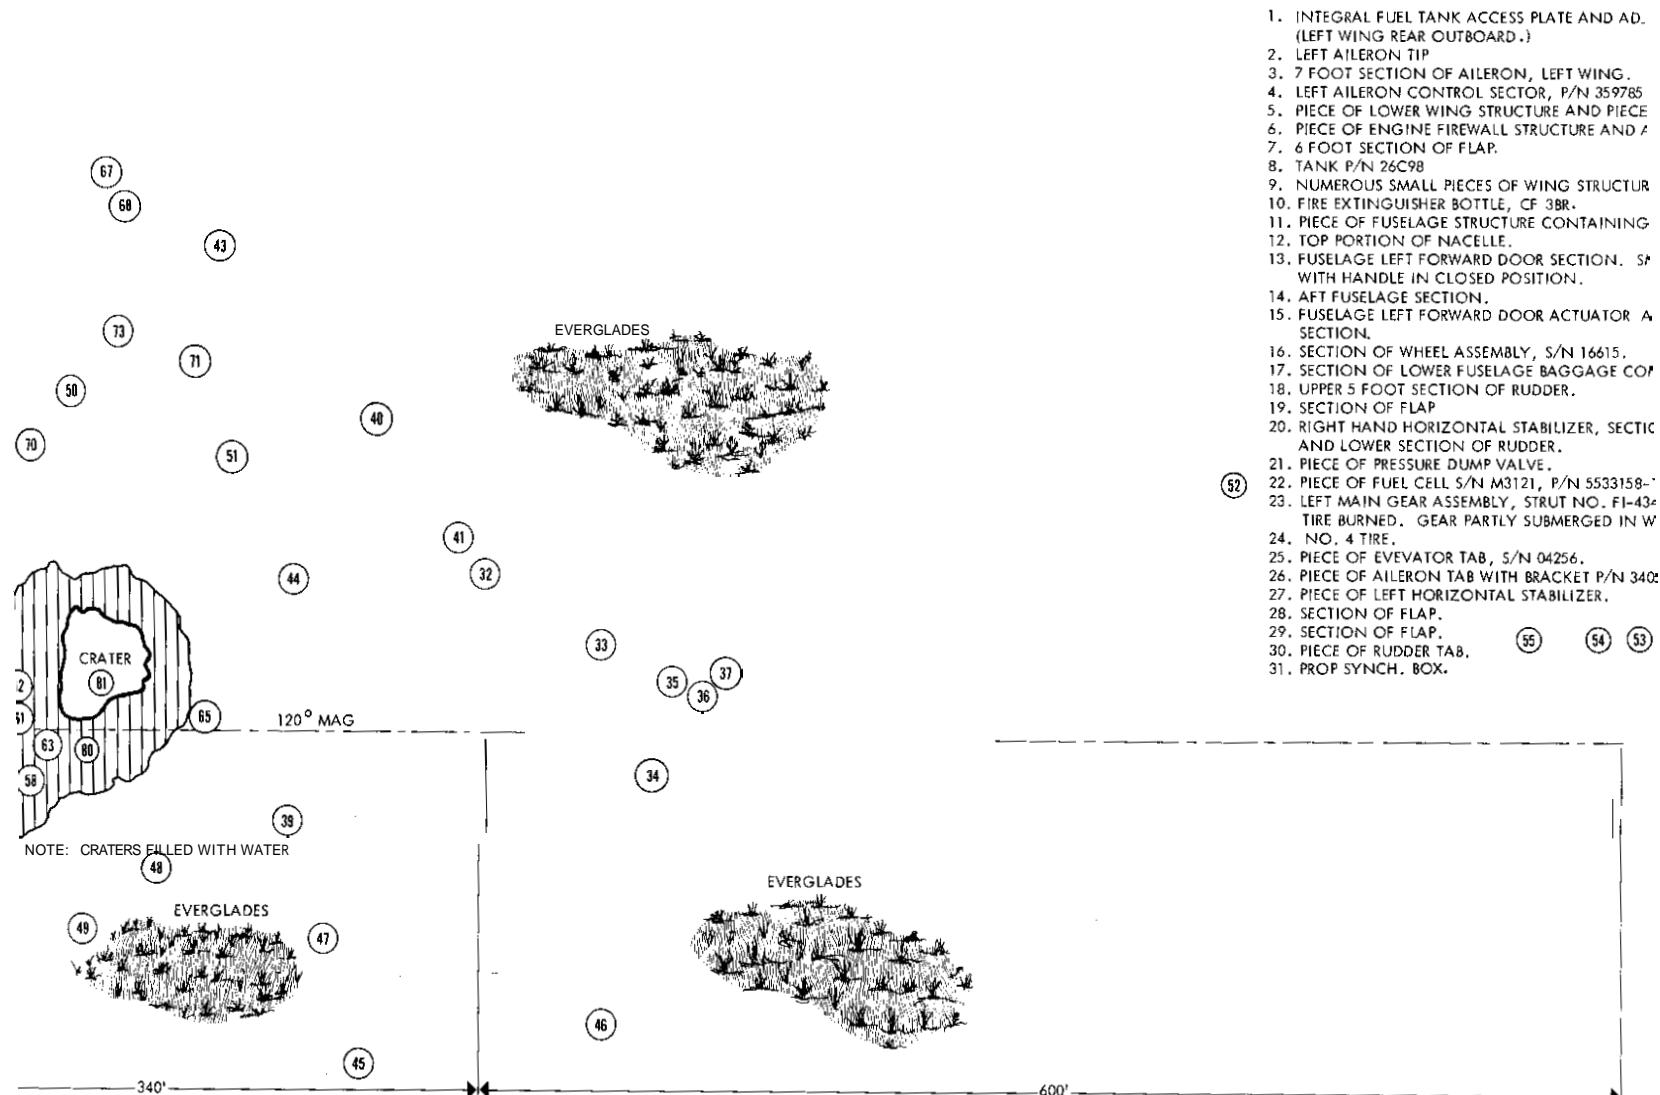
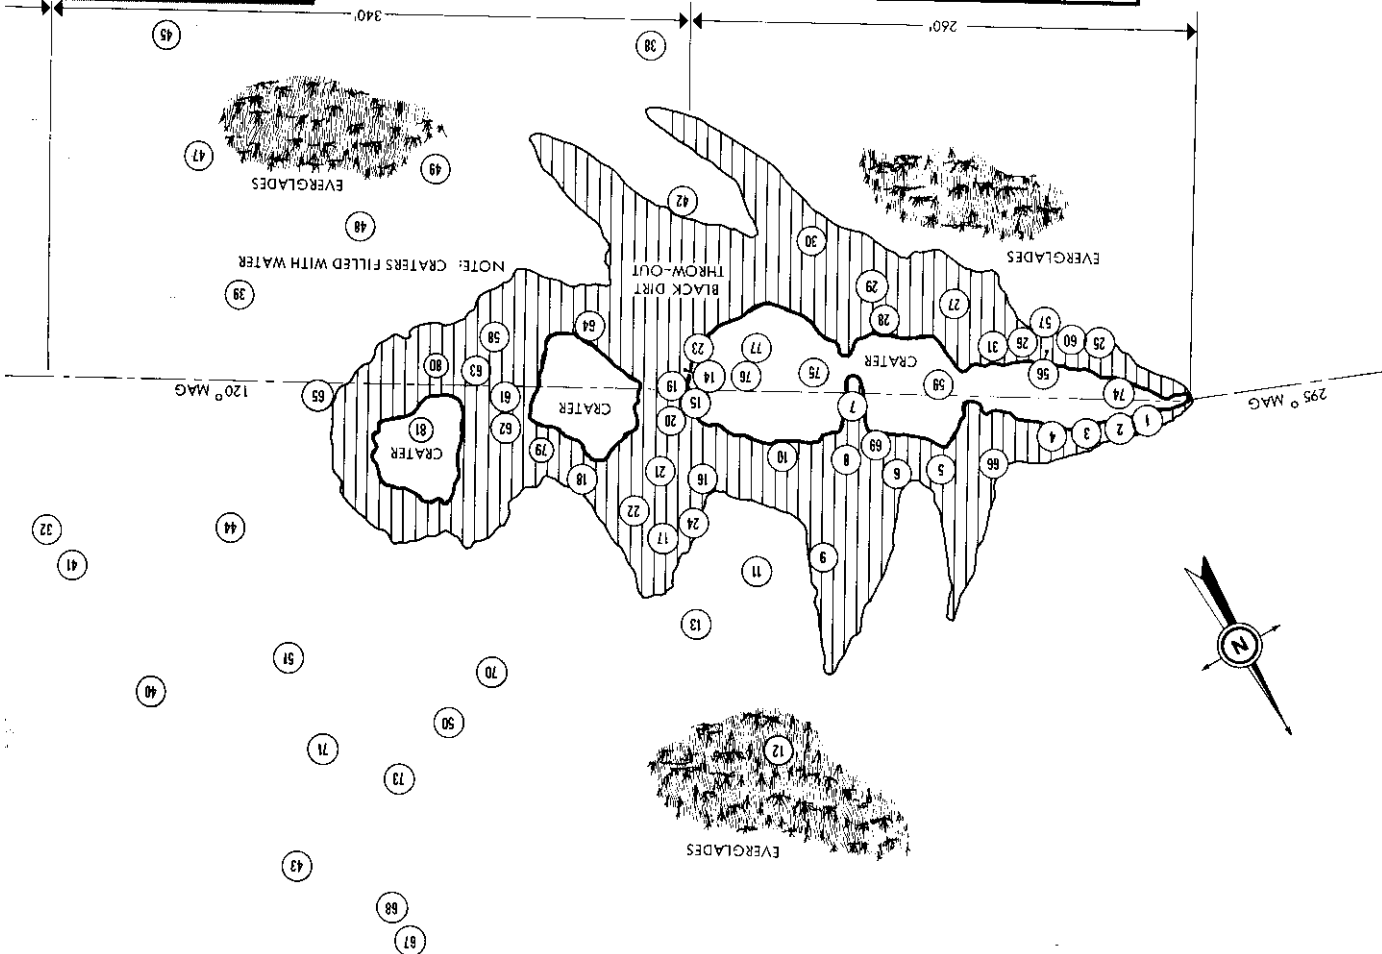
1. INTEGRAL FUEL TANK ACCESS PLATE AND AD. (LEFT WING REAR OUTBOARD.)
2. LEFTAILERON TIP
3. 7 FOOT SECTION OFAILERON, LEFT WING.
4. LEFTAILERON CONTROL SECTOR, P/N 359785

5. PIECE OF LOWER WING STRUCTURE AND PIECE
6. PIECE OF ENGINE FIREWALL STRUCTURE AND
7. 6 FOOT SECTION OF FLAP.
8. TANK P/N 26C98
9. NUMEROUS SMALL PIECES OF WING STRUCTUR

22. PIECE OF FUEL CELL S/N M3121, P/N 5533158-
23. LEFT MAIN GEAR ASSEMBLY, STRUT NO. FI-43- TIRE BURNED. GEAR PARTLY SUBMERGED IN W
24. NO. 4 TIRE.
25. PIECE OF EVEVATOR TAB, S/N 04256.

71. VERTICAL SECTION OR RIB OF INTEGRAL FUEL TANK SHOWING EVIDENCE OF  
SOOT EMANATING FROM PIPE HOLE.
72. FUSELAGE SKIN
73. RIGHT WING TIP.
74. FRAGMENTED PIECES OF INTEGRAL FUEL TANK OUTBOARD WING PANEL  
FIRE DAMAGED.
